ILLINOIS ENVIRONMENTAL PROTECTION AGENCY

Livestock Facility Inspection Checklist

Fehr Brothers Swine Farm -
Woodford County
April 26, 2013
(IEPA)

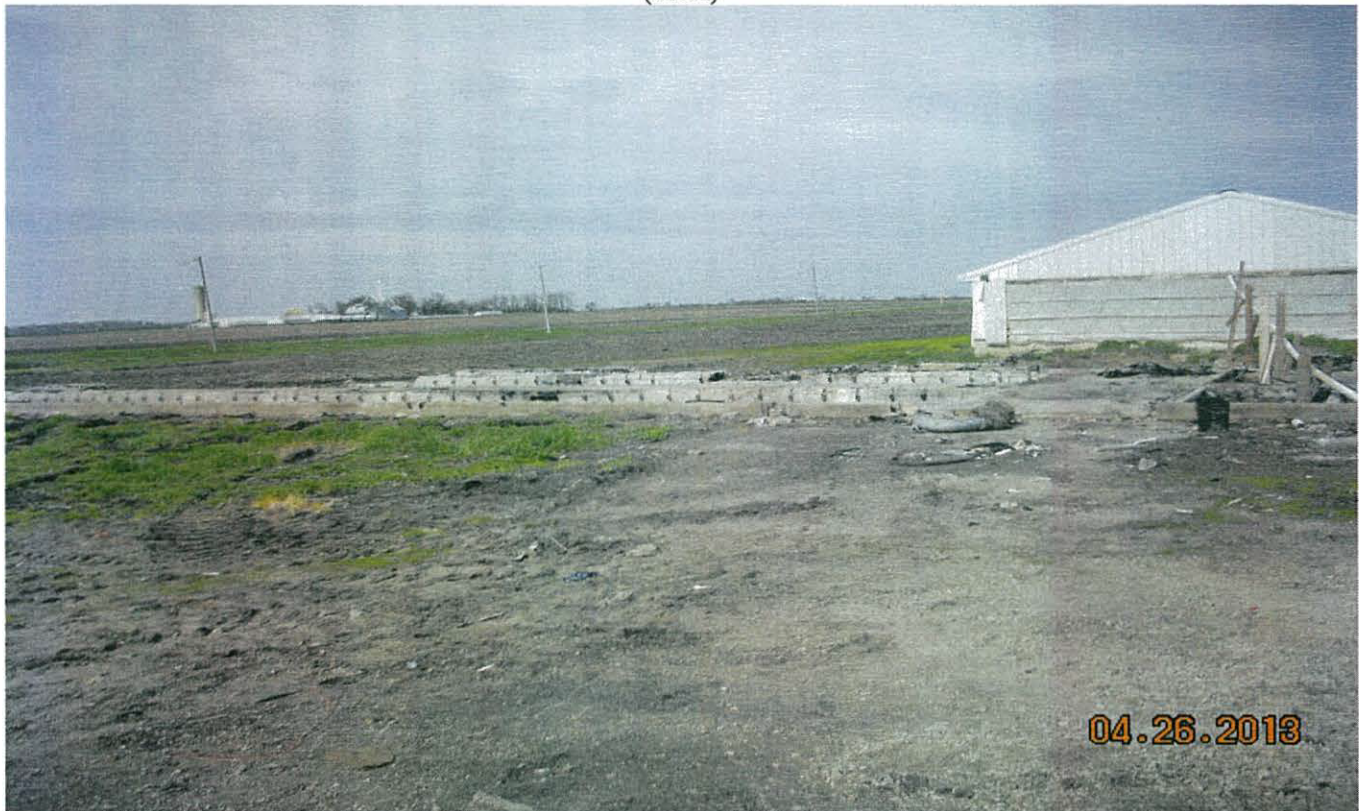
Photograph #1. The fire-damaged Nursery Building is shown. View is southwest.

There were two other total confinement buildings the gilt development and nursery building. These were burnt down in a fire in January 2013. There is still some debris from the fire left at the facility. These buildings were reported as going to be cleaned as soon as possible with the manure in the partial pits properly land applied. During the inspection these pits had approximately 2' freeboard. It was reported that the freeboard on these pits would be properly checked to insure no release of manure would occur.

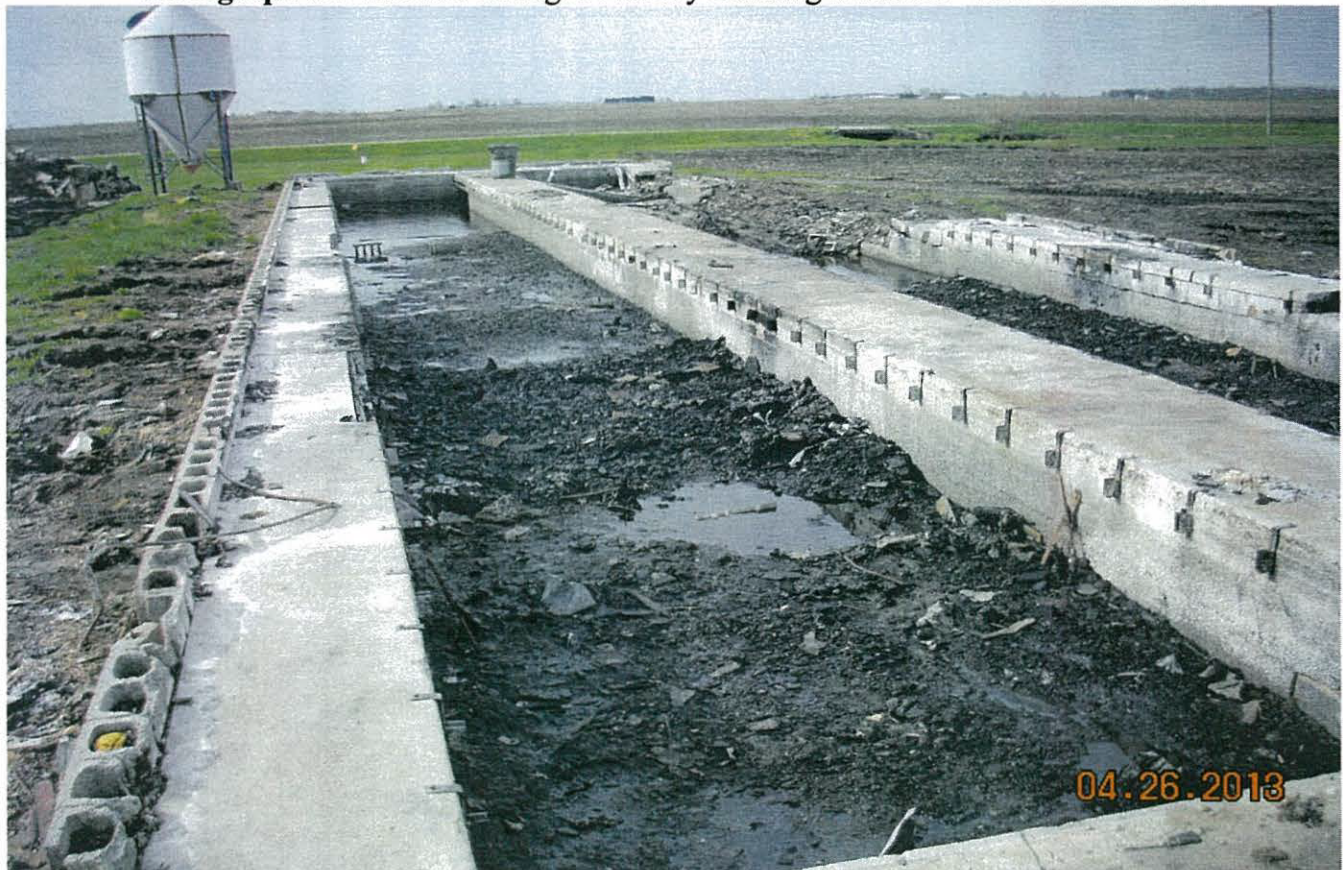
Photograph #2. The manure storage pits at the fire-damaged Nursery Building are shown. View is south.

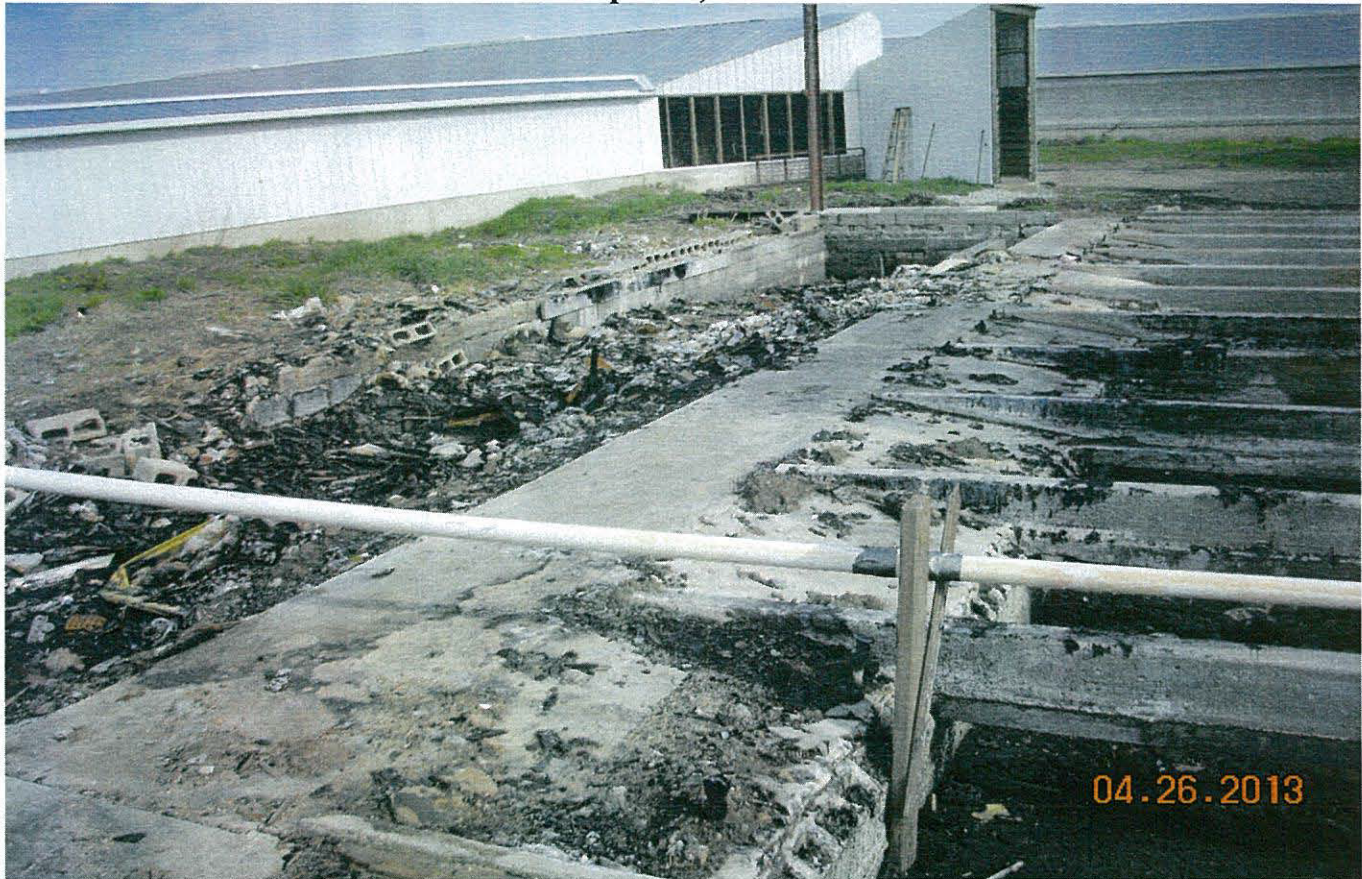
Photograph #3. A portion of the fire-damaged Nursery Building is shown in the foreground. View is north.

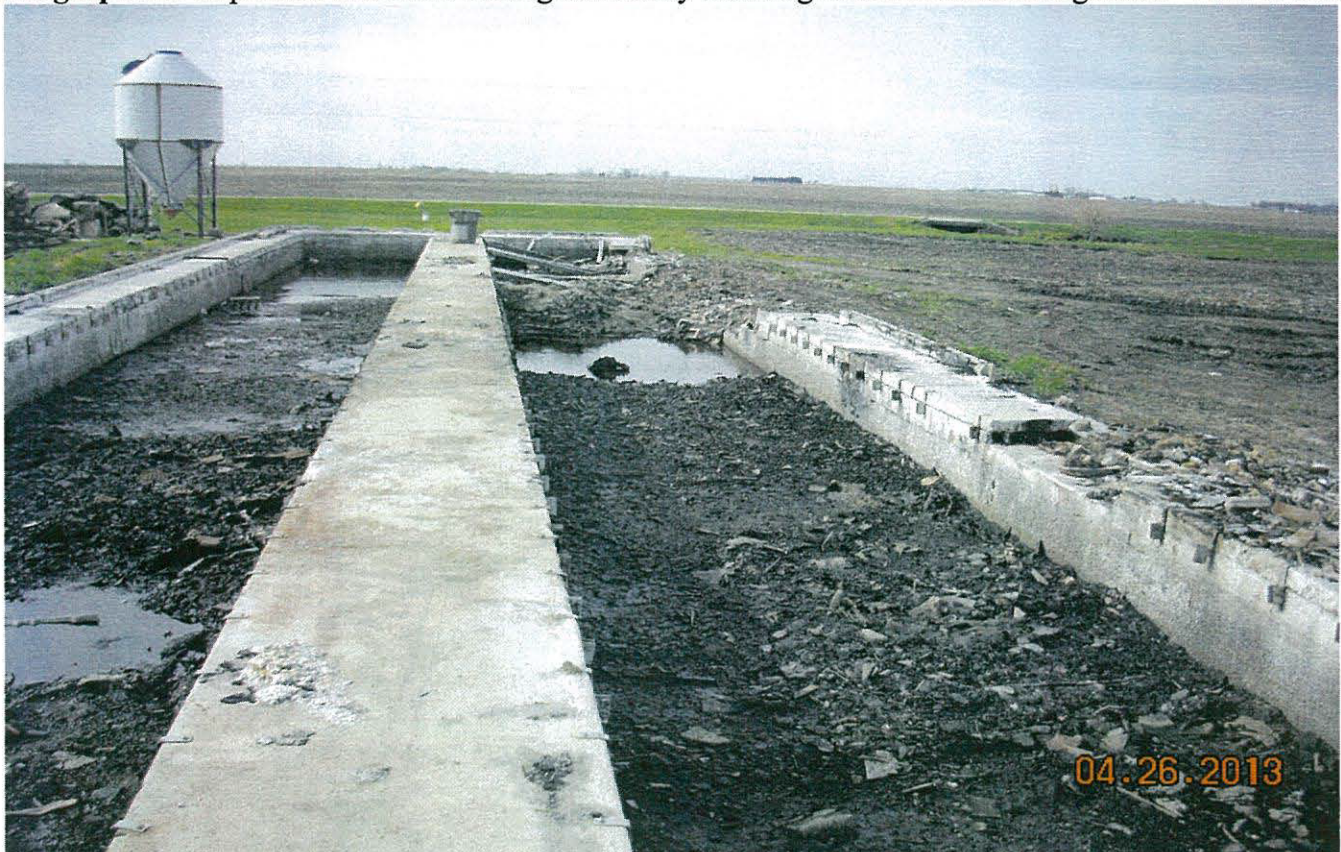
Photograph #4. The manure storage pits at the Nursery Building are seen. View is south.

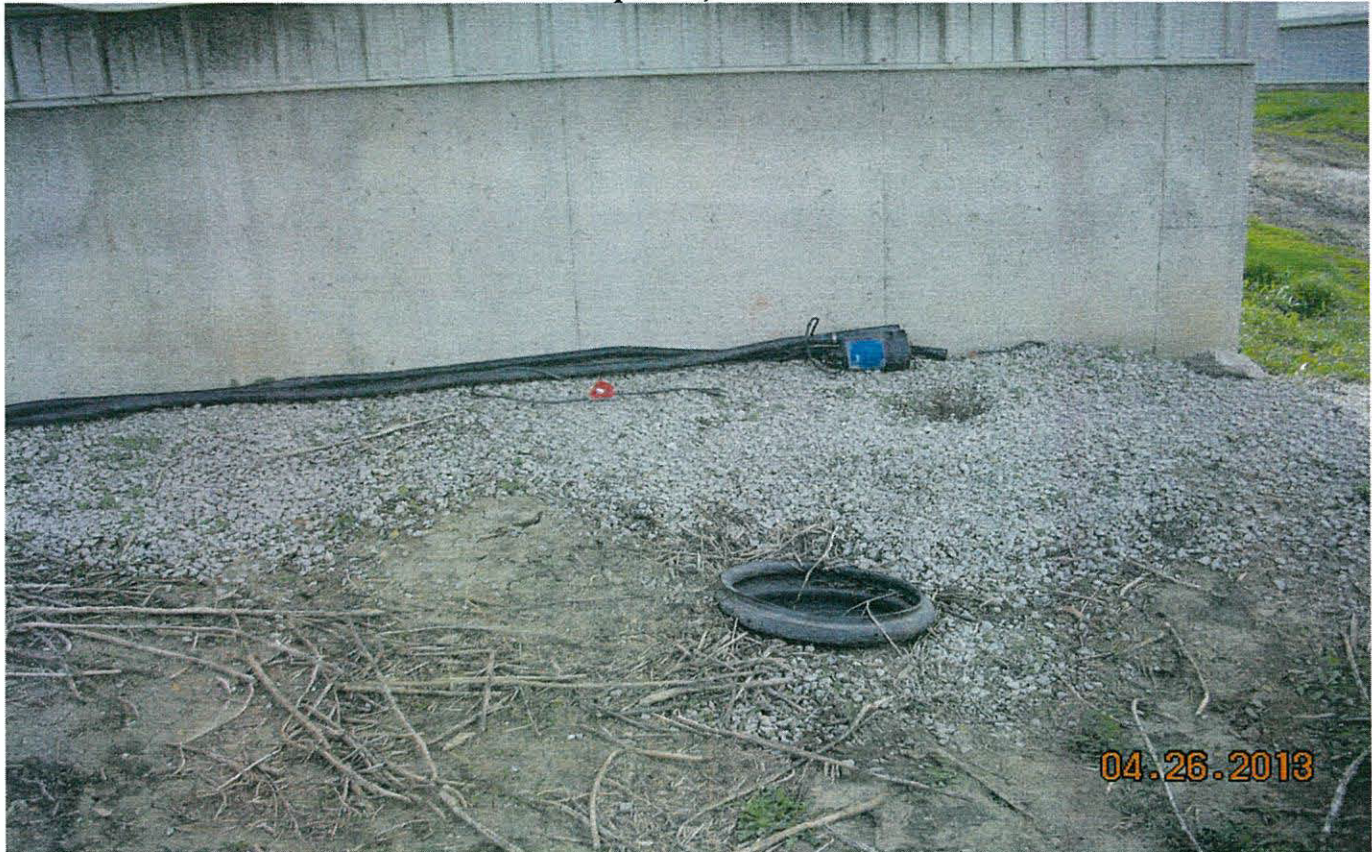
Photograph #5. The top of a perimeter tile sampling port is seen at west end of a swine confinement building.

Station BD-1 identifies a liquid sample collected from the south total confinement building, Building 1, Perimeter Tile. This sample was slightly turbid with a slight brown color.

Station BD-3 identifies a liquid sample collected from the north total confinement building, Building 3, Perimeter Tile. This sample was clear in color with a few dark particles. This sample had a slight odor occurring.

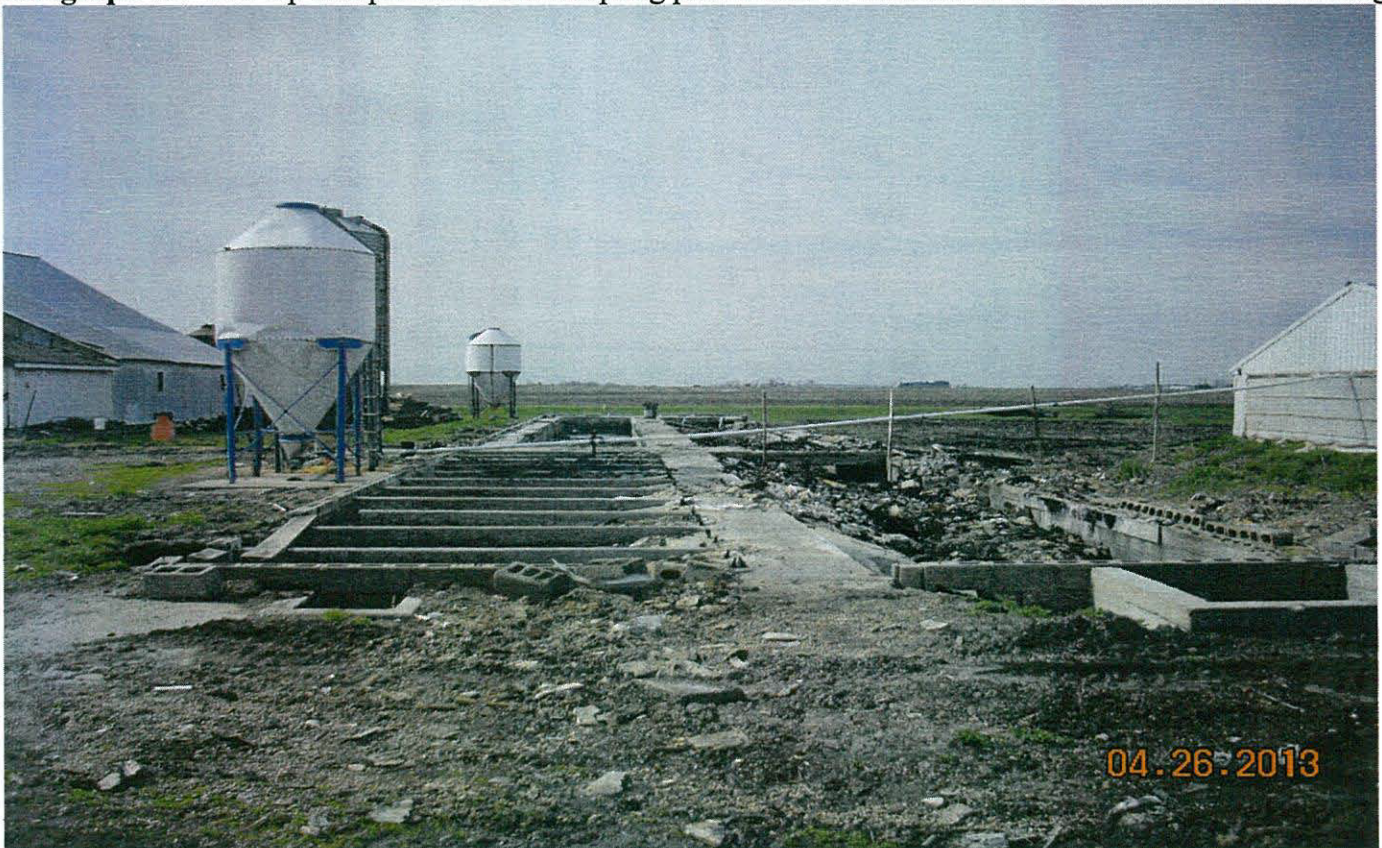
Photograph #6. The current condition of fire-damaged Nursery Building is shown. View is south.
c:\livestock\fehr_bros_swine_farm\jared\photos_digital_april_26_2013.doc
